Manhole Inspection Summary

Manhole # S19G__011MH

Insp Date: **10/8/07 10:48 AM**

Location Address: **2000 VINE-FAYETTE**

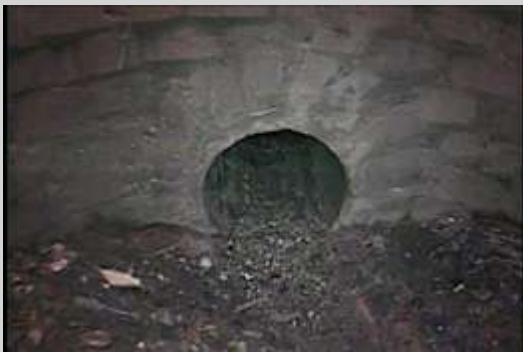
12 O'Clock Outflow

8 in. Circular Gravity Sewer
Pipe Out @ 12 O'Clock

Pipe Height: **7.2** (in.) Rod and Bar (Angled)
Pipe Material: **Clay** ☐ Pipe Lined
Invert Depth: **6.20** (ft.) Flow Characteristics: **None**
Deposits: ☒ None ☐ Mud ☐ Sludge ☐ Debris ☐ Grease
Silt Depth: **1** (in.) Deposits Extent: **Light**
Infiltration: **None** Pipe Seal Cond: **Sound**

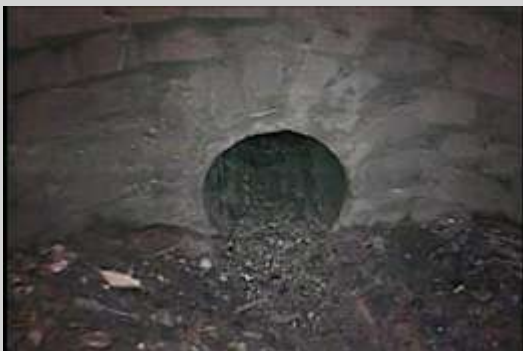
12 O'Clock Outflow

8 in. Circular Gravity Sewer
Pipe Out @ 12 O'Clock

Pipe Height: **8.4** (in.) Rod and Bar (Angled)
Pipe Material: **Clay** ☐ Pipe Lined
Invert Depth: **12.81** (ft.) Flow Characteristics: **Slow**
Deposits: ☒ None ☐ Mud ☐ Sludge ☐ Debris ☐ Grease
Silt Depth: (in.) Deposits Extent:
Infiltration: **None** Pipe Seal Cond: **Sound**
